ADDENDUM NO. 2

SUBJECT: DPW PROJECT NO. 23882
State of Idaho Deferred Maintenance Program
University of Idaho; Moscow, ID

College of Law Slab Settlement Study

FACILITIES SERVICES COMPLEX EXTERIOR EVALUATION UNIVERSITY OF IDAHO MOSCOW, IDAHO

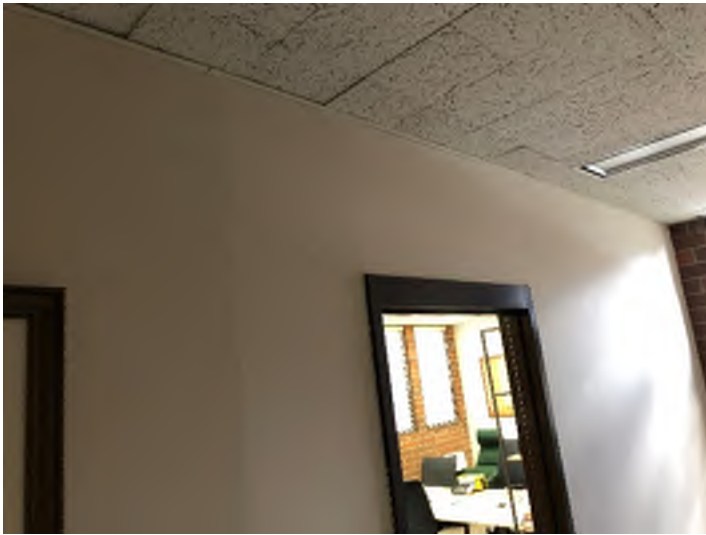
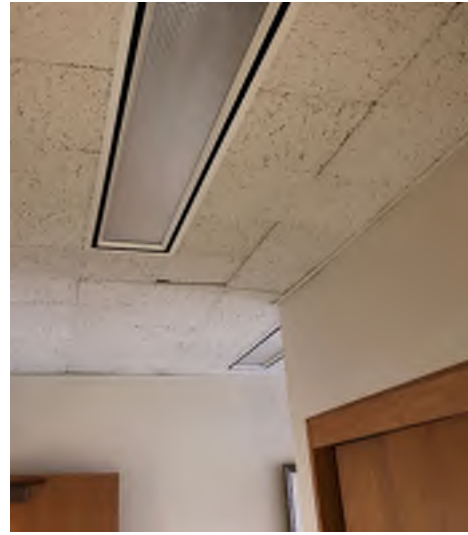
Wall cracking/separating at doorway openings and buckling ceilings.

2. Cut out and remove the areas of concrete slabs that have deflected to unacceptable grade levels. To efficiently and effectively perform this work, it is recommended that settled and damaged walls in the affected areas be removed and reconstructed over new concrete slabs. The concrete slab areas with acceptable grades/elevations to remain and areas to be removed would need to be verified and clearly demarcated.

6. In addition to removing select walls, it is recommended to remove the existing spline/tile ceiling system and provide a new suspended acoustical tile ceiling system at the same elevation. The existing spline system is damaged where walls have settled and the splined tiles make maintenance access above the ceiling difficult. A new suspended acoustical tile system would facilitate the installation of the new HVAC ductwork and related ceiling grilles and diffusers and make above ceiling maintenance more accessible.

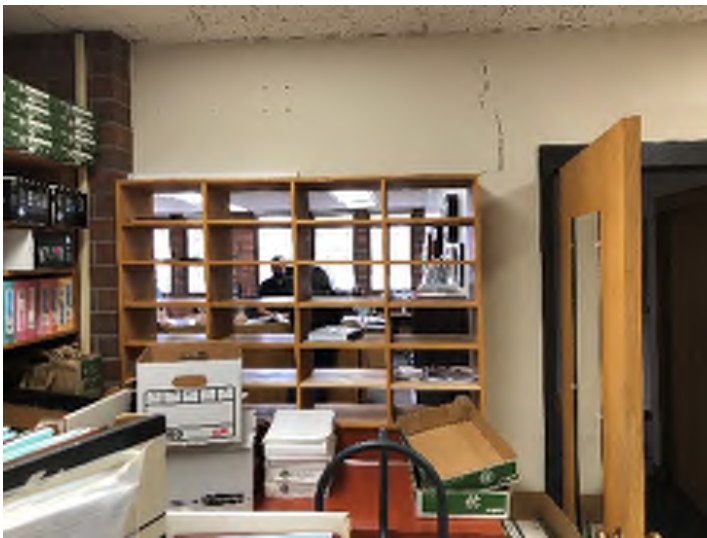
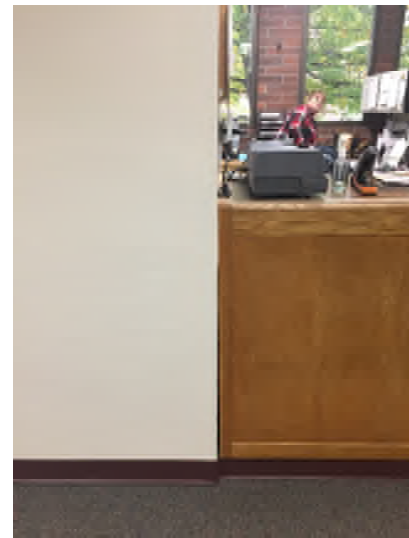
Wall cracking/separating at doorway openings and casework.

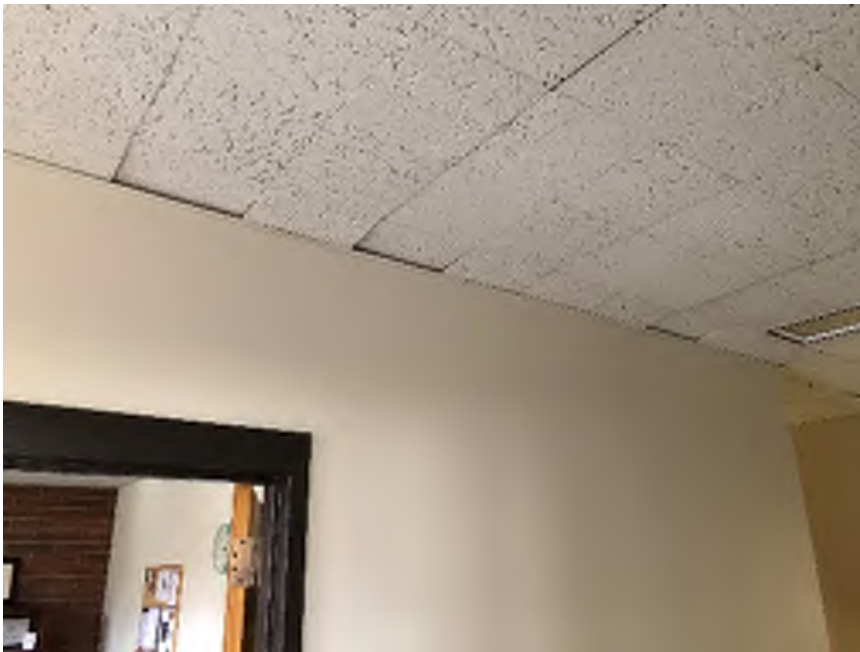
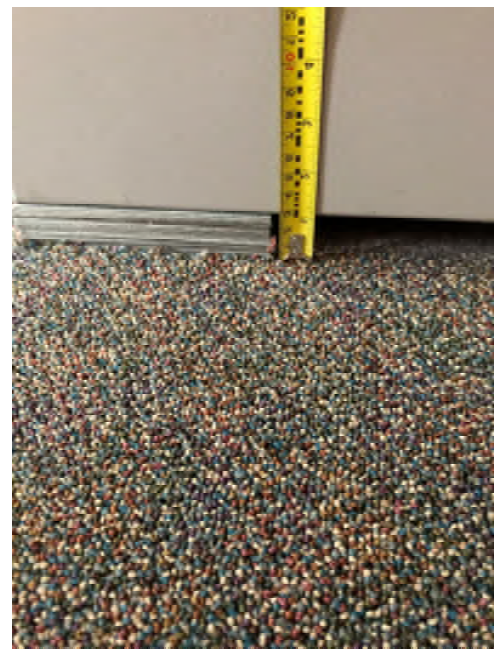
Spline tile ceiling system displacement and floor deflection.

5. Provide new concrete slabs in the areas where deflected slabs are removed. These slabs should be 4" thick and reinforced to bridge any residual discrepancies in the subsurface conditions and support heavier point loads. The new concrete slabs would be doweled into the existing, adjacent concrete slabs to remain.

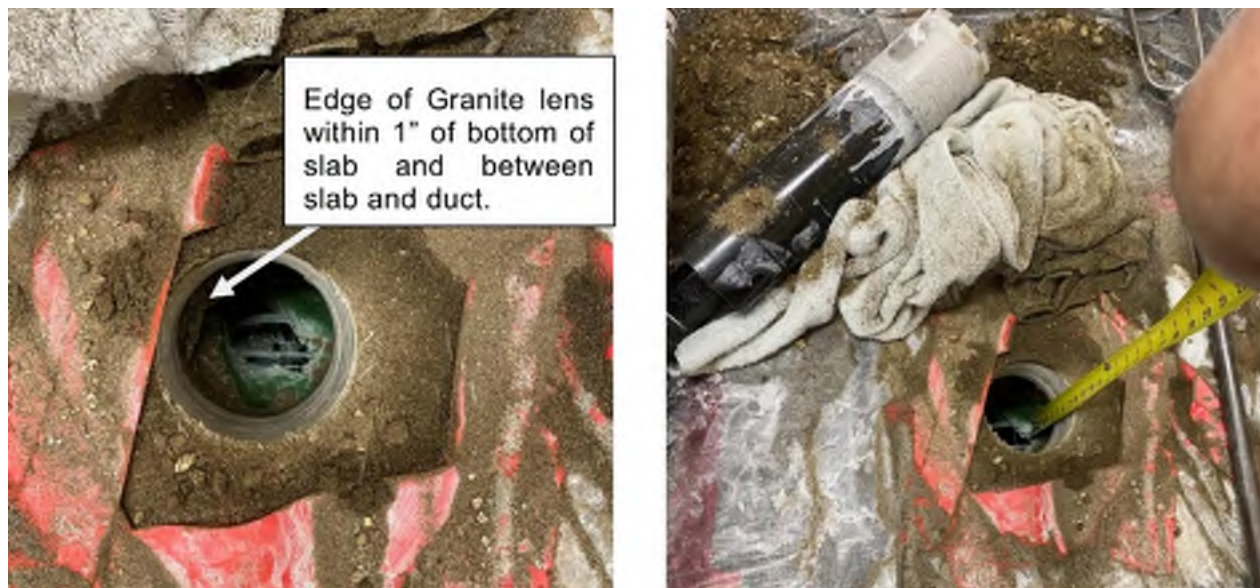
The first sample was taken on May 27th, 2021. During this initial coring, underground ductwork was encountered approximately 1" below the concrete slab, puncturing the ductwork. It was decided to suspend additional coring until such time as existing underground infrastructure could be located. TD&H was able to gather enough subsurface soil at this time to send to their soil laboratory in Great Falls Montana to test the soils using Atterberg limits to classify the soil profile.

First sample taken on May 27th, 2021 showing ductwork found below the concrete slab.

3. Abandon the underground ducts and fill with CDF (Controlled Density Fill). CDF is a flowable, self-leveling, cementitious slurry consisting of a mixture of fine aggregate or filler, water, and cementitious material(s), which is used primarily as a backfill in lieu of compacted earth. This mixture is capable of filling voids in hard to reach places without the need for compaction in layers. New HVAC ducting would be provided above the ceiling to replace that being abandoned.

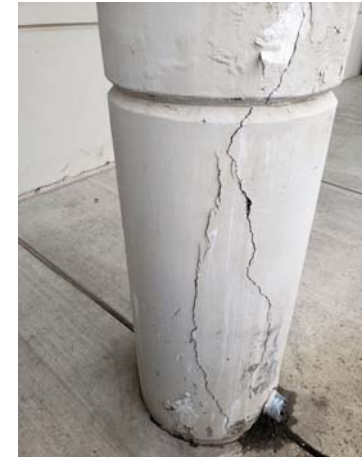
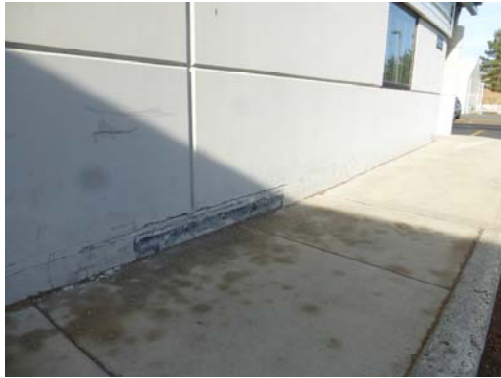
- All columns on both the north and east sides of the building show some degree of cracking ranging from minor surface cracks that would be considered normal to severe cracks and spalling that are up to a half inch wide. The most severe cracking is located at columns on the north side of the building that have downspouts cast inside them. It appears the downspouts are freezing and adding to the cracking of these columns.
- The columns have two chamfer features, that when the columns were cast, were to align with two chamfer features in the tilt-up wall panels and the top and bottom of the windows. The bottom column chamfer was cast higher than the one in the pre-cast panels and the bottom of windows. To correct this the chamfer was filled and a new chamfer ground into the columns. The filled in chamfers at each column are starting to crack and spall.

- Where columns are cracked and spalled remove loose concrete, clean reinforcing steel, patch back where material is removed and inject cracks with an epoxy adhesive.
- Cap off internal downspouts and install open face downspouts on the surface of the columns.
- Where chamfers are spalled remove spalled material and patch back with an epoxy based filler.
- At the base of the concrete wall panels, grind out grout as needed to install a backer rod and a polyurethane caulking.

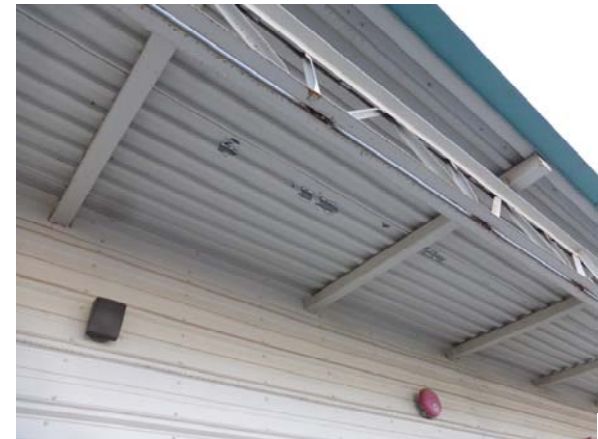
- Roof overhangs along the north and east side of the building are constructed of exposed metal roof decking over exposed steel trusses. In several locations both the steel deck and roof trusses have rust starting to form and areas of peeling paint. In addition, metal door frames at the north loading dock and along the south side of the building are also developing areas of rust at the bottom of the frames.

- At locations where the concrete has deteriorate at the base of the concrete wall panels remove loose material clean and patch back.
- At roof overhangs sand blast rust areas at the steel trusses and areas where paint is peeling at roof deck.
- Sand blast rusted areas at door frames.
- Paint exterior walls, doors, door frames, and trusses.
- Replace the damaged gutter on the north side of the building and the damaged fascia on the south side of the building.
- Install crickets at the up slope side of all light wells and exhaust fan penetrations.
- Install snow bars where torn off at east metal roof.
- Within the next three to five years the single ply roofs should be replaced. The exception to this is the single ply roof at mechanical well should be replaced as soon as practical. This would allow inspection of the roof deck for deterioration.

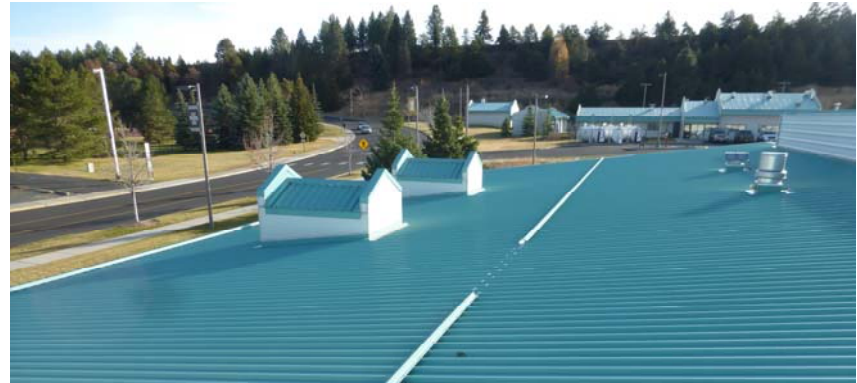
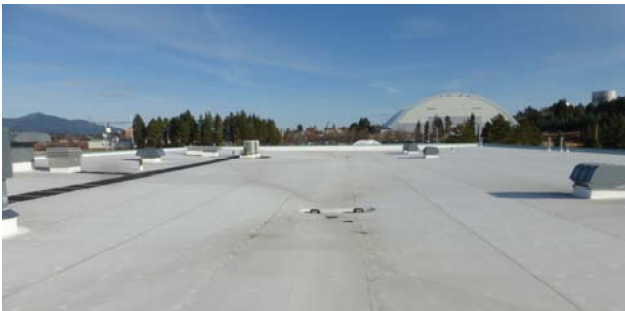
- Enclosed light wells and exhaust fans located on the east and north metal roofs were to originally have crickets installed on the up slope side. A flat piece of metal flashing was installed instead of the cricket which is allowing snow and water to back up against the light wells and exhaust fans causing leaking to occur.
- At the metal roofs snow bars are located along the eaves and approximately half way up the roof slopes. On the east metal roof a section of the upper snow bar has been torn off.

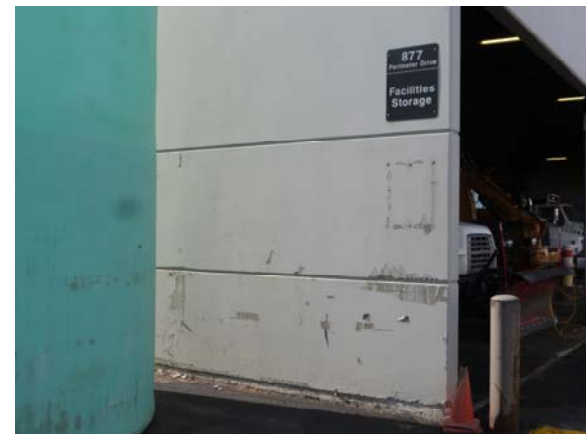
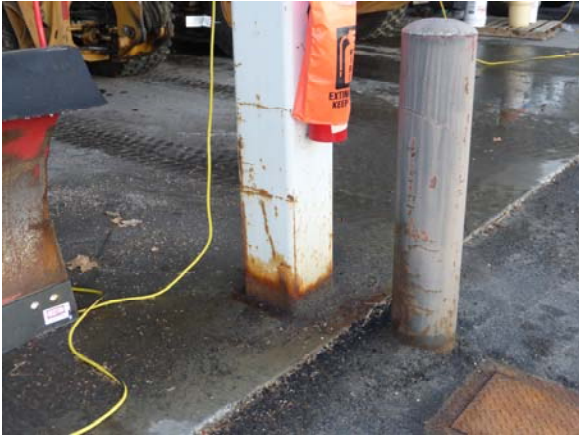
- Tilt-up wall panels were installed in the same manner as the Main Facility Services Complex Building which is on concrete stem walls using shims rather than being placed directly on footings. The panels are attached to the stem walls with a series of weld plates and non-shrink grout was then installed. The non-shrink grout at the base of the concrete panels is deteriorating because of panel movement at the joint, and being at or near grade.
- Paint on the walls has areas of peeling and has been scuffed and damaged from equipment scraping the building.

- At the base of concrete wall panels grind out grout as needed to install a backer rod and a polyurethane caulking.
- At locations where the concrete has deteriorate at the base of the concrete wall panels remove loose material clean and patch back.
- Sand blast the rusted weld plates and column, prime and paint.
- Paint the exterior of the building.
- Within the next three to five years, the single ply roofs over should be replaced.

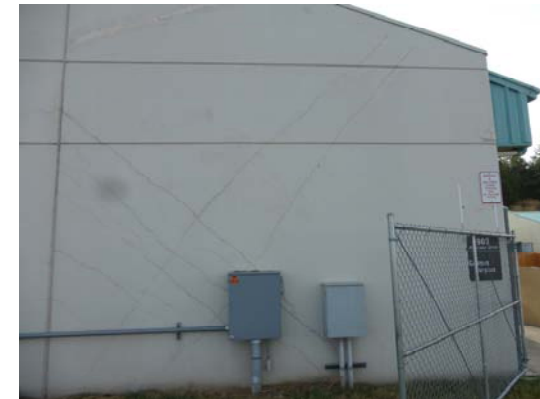
- The tilt up concrete panel that forms the north end wall has several diagonal cracks that form a cross hatch pattern. The depth of the cracking could not be visually confirmed but do not appear to extend through the wall. When tapped the wall has a hollow sound indicating separation of the finished concrete surface from the underlying concrete. It appears the cracks extend into the wall to where the separation is occurring creating the cross hatch pattern.
- Wall panels adjacent to one of the overhead doors have been run into and bottom three feet of the panels dented in.
- The fascia above one of the overhead doors has been run into and damaged.

- At the north end wall, remove loose material from cracks and inject with an epoxy based adhesive and patch back.
- Replace damaged metal wall panels.
- Replace gutter at valley and install a downspout leader box and heat tape.
- Repair damaged gutter.
- Replace damaged fascia above the overhead door.
- Replace parapet caps.
- Paint concrete walls.

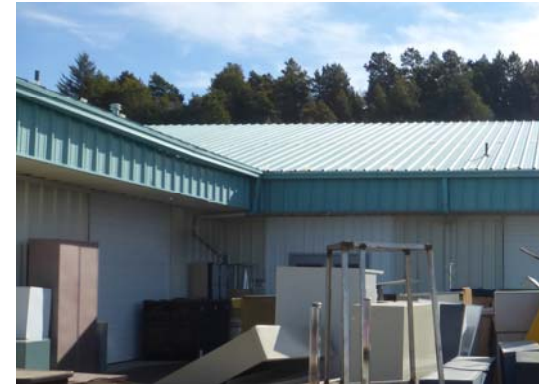
- Building users indicated that where the two wings of the building that form the “L” shape meet and create a roof valley large icicles form that can extend to the ground.

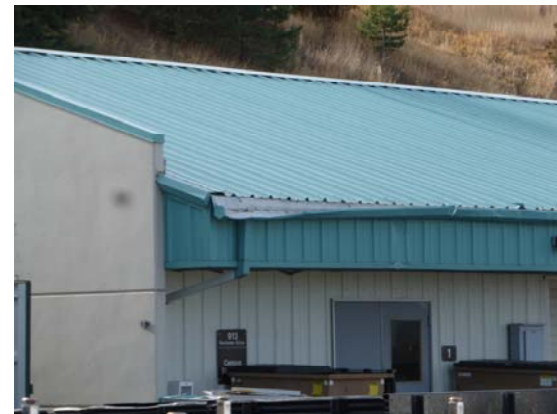
- Gutter along the north side of the building is damaged and in various stages of being torn off the building. There are no snow bars installed on the building.

- Replace gutter and install snow bars the length of the roof
- Replace damaged eave siding.
- Replace or reinstall foam closure strips
- Paint concrete walls

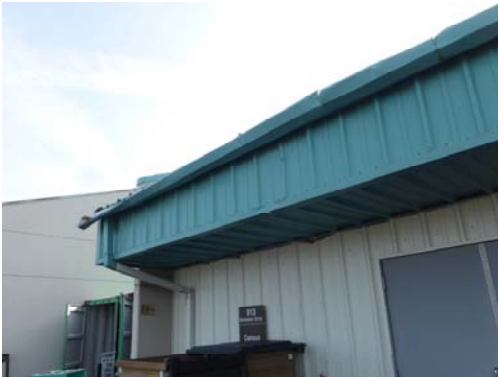
- Metal siding forming the eave of the roof has been hit by a tall vehicle at one of the overhead doors.

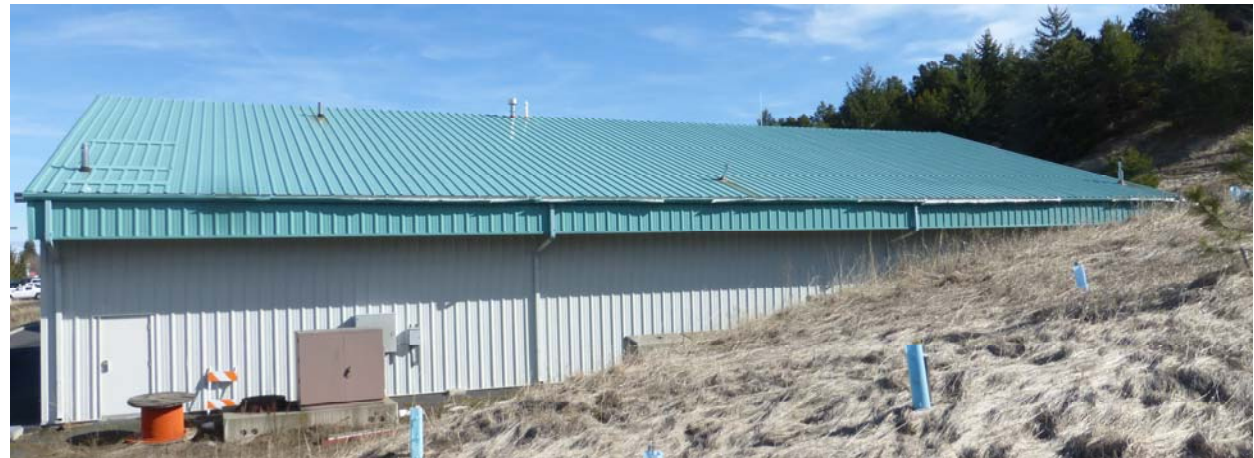
- On both east the west side of the building snow bars are only over the man door and overhead doors.
- Gutters are damaged on both the east and west sides of the building where snow bars were not installed.

- Install snow bars in locations where they were omitted.
- Replace Gutters.

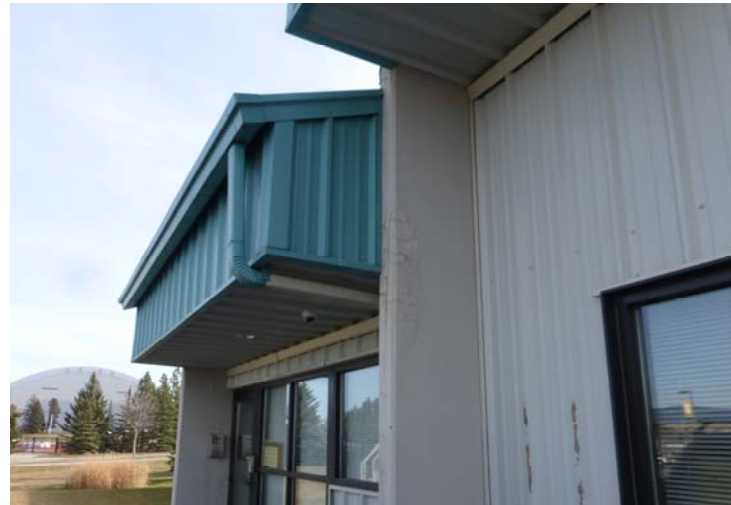
- The west pre-cast concrete wall at the center section of the building is cracking at the north end of the wall.

- At cracked concrete wall panel remove any loose concrete, patch back where material is removed and inject cracks with an epoxy adhesive.
- Clean and paint concrete walls.
- Install new prefinished parapet caps.

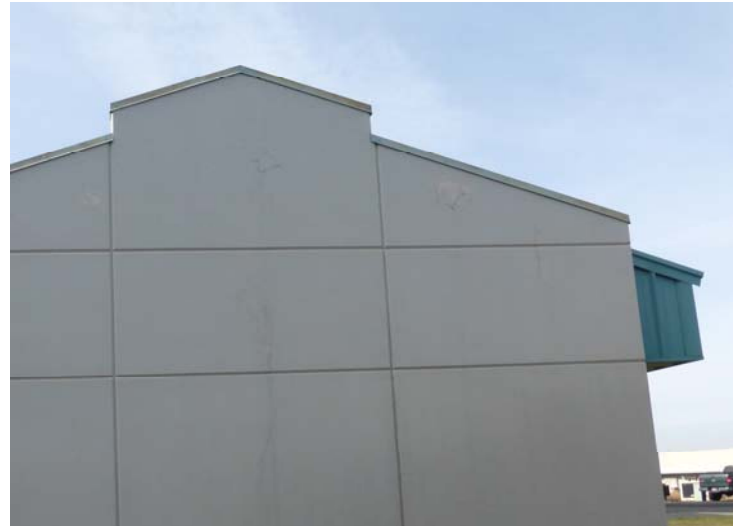
- Paint is peeling at all four of the concrete walls.
- Parapet caps are rusting and starting to deteriorate.

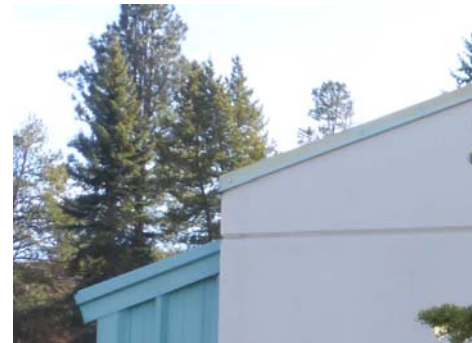
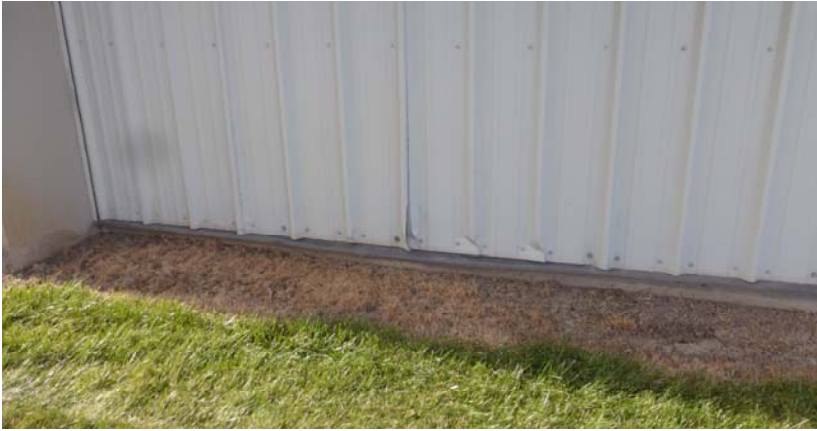
- Paint at the concrete end walls is peeling.
- Parapet caps are rusting and starting to deteriorate.

- Clean and paint concrete walls.
- Install new prefinished parapet caps.
- Replace damaged metal siding panels.

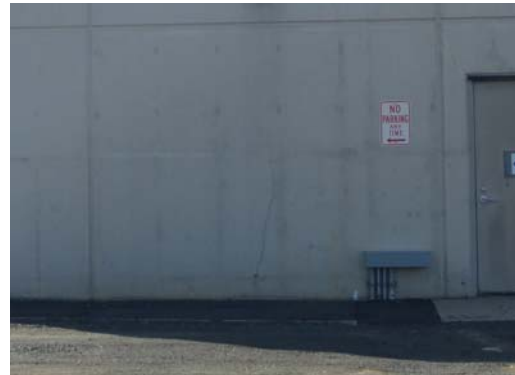
- At the center of the east wall a crack has formed that appears to have been caused by settlement.
- Paint is peeling in several locations and the walls are stained.

- Inject crack in east wall with an epoxy based filler.
- Clean and paint exterior walls.

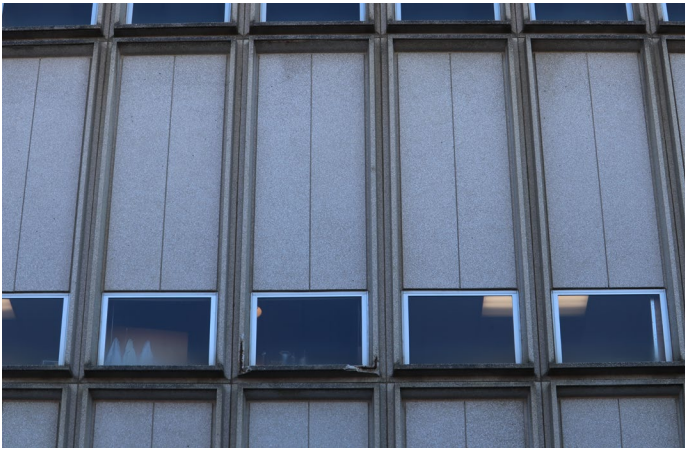
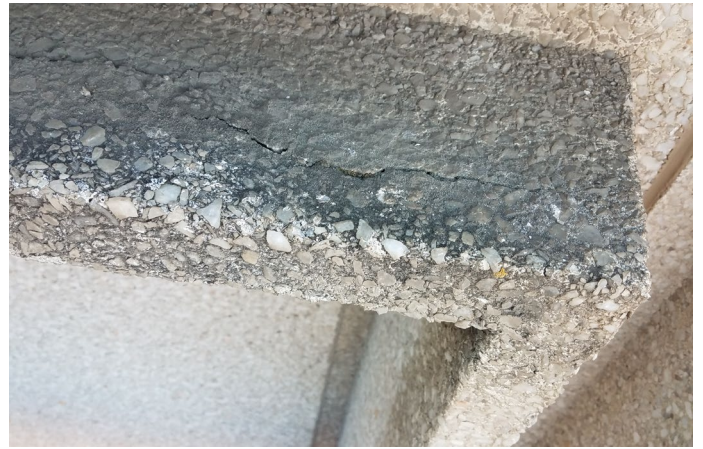
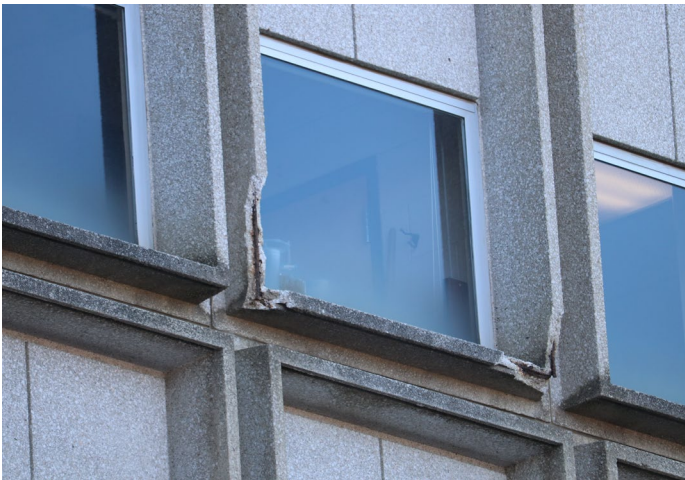
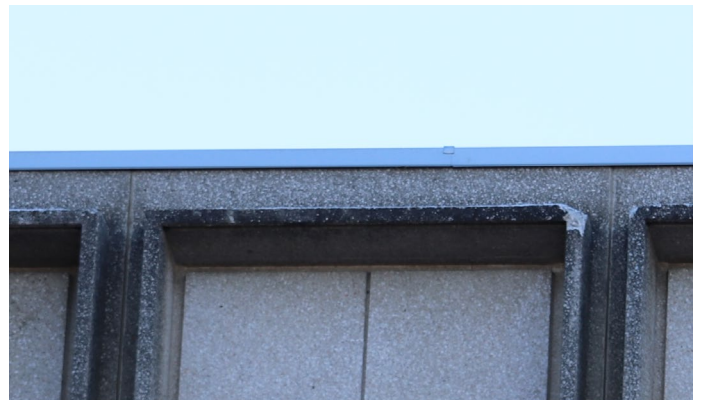
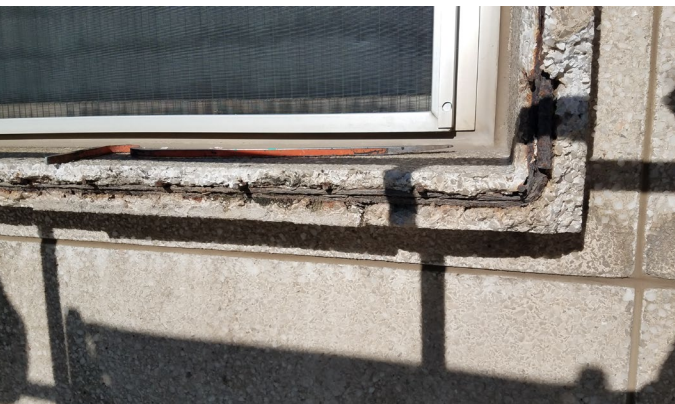
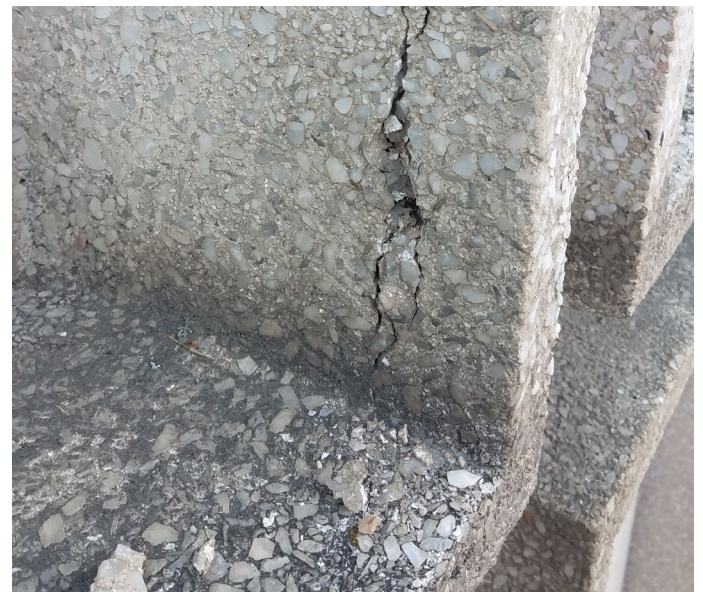
EXAMPLES OF EXTENSIVE DAMAGE

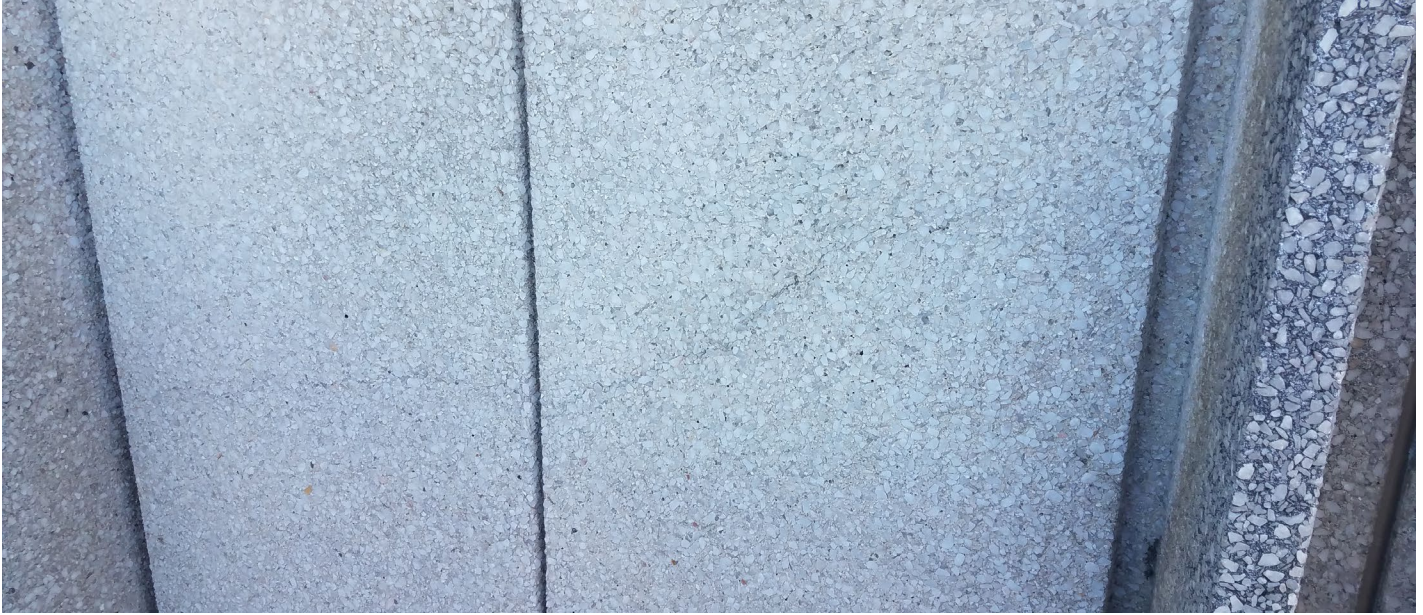
CRACKED PANEL

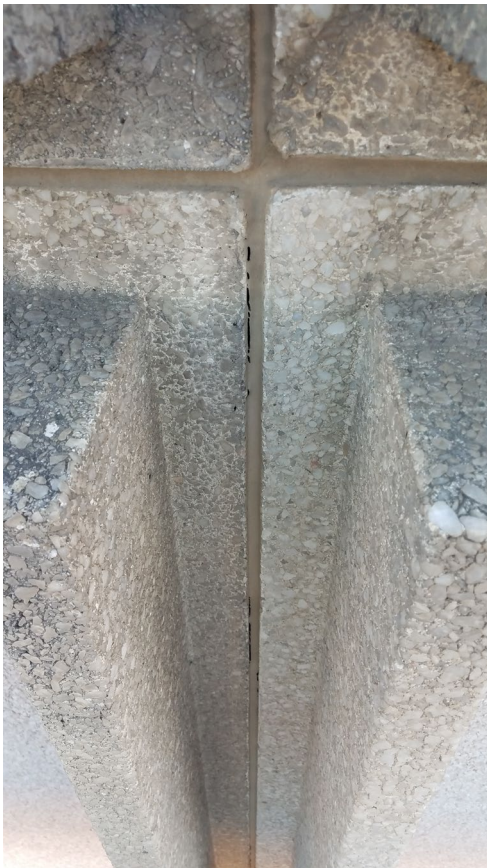
FAILING JOINT COMPOUND

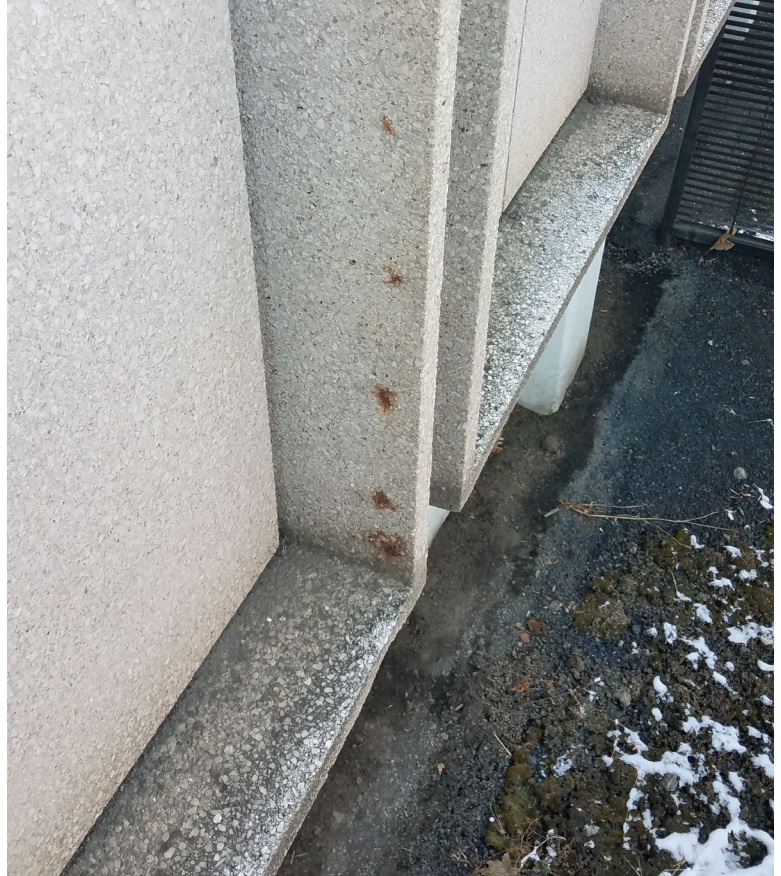
VISUAL RUST SPOTS
